EnviroDIY in the Delaware River Basin

Informal summary monitoring results and station usage, successes/challenges, and recommendations

Description of document: The following contains informal summaries of some of the projects taking place in the Delaware River Basin using EnviroDIY monitoring stations equipped with CTD and Turbidity sensors. Stations are owned and managed by individual watershed groups and schools. Support has been provided by Stroud Water Research Center via the Delaware River Watershed Initiative. Summaries were voluntarily prepared by station owners/managers at the request of the Stroud Center. For more information contact dbressler@stroudcenter.org.

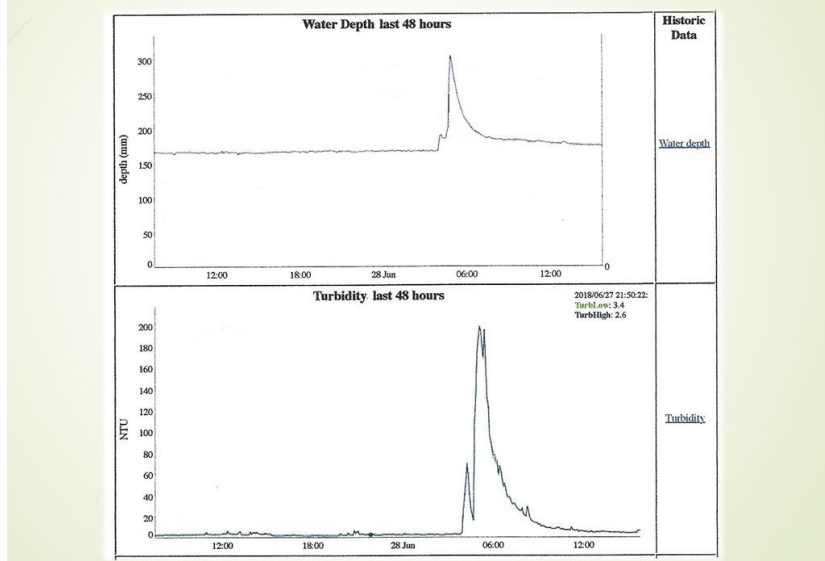
Data from Storm Event of June 2019

Here are data from a rain event on June 28, 2019. The upper panel shows stream depth as a function of time on the X-axis. Prior to the start of rain, Broad Run was at its typical base flow of 6". When the rain started around 4 AM, stream depth quickly doubled to 12", then recovered fairly quickly. This was a moderate rain event. We have seen heavy rains elevate stream depth at this site to almost 3 feet.

The turbidity sensor (lower panel), whose data are expressed in Nephelometric Turbidity Units (NTU), tracked quite closely with changes in stream depth. The most recent 48 hrs are routinely displayed, but the data are archived, so we can revisit past rain events if necessary. Our hope was that with sufficient data we might be able reliably to correlate these NTU data with actual sediment load into Somerset Lake. But the lake doesn't fill with NTUs, it fills with dirt. So initially we had to measure sediment loads directly.

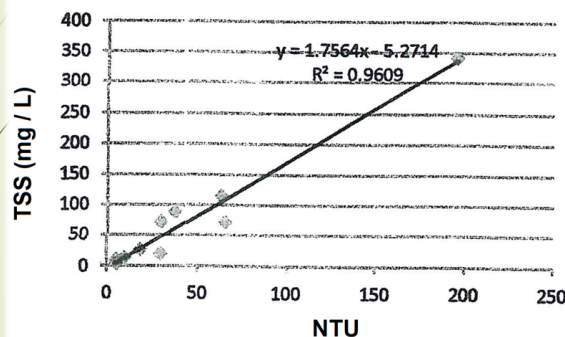
Total Suspended Solids vs Turbidity

TSS vs NTU

Total Suspended Solids (TSS):

- Collect Stream Sample
- Filter known volume of sample through pre-weighted sample paper
- Dry paper for 24 hours
- Weigh filter paper plus collected solids
- Subtract weight of filter paper
- Express data as milligrams of dry solids per liter of sample (TSS)

And the way we do that is by measuring Total Suspended Solids (TSS). We collect a stream sample, filter a known volume of sample through a pre-weighed filter paper, and dry the paper for 24 hrs. Then we reweigh the filter paper containing the collected solids, subtract the weight of the paper, and express the data as mg of dry solids per liter of original sample. It's Science putting a number on how muddy the stream looks. For quick reference, if TSS is less than 10, the stream looks clear. If TSS is in the hundreds, the stream is definitely turbid. And if TSS is in the thousands, Broad Run looks like it is carrying liquid mud. That has happened several times in the past 18 months.

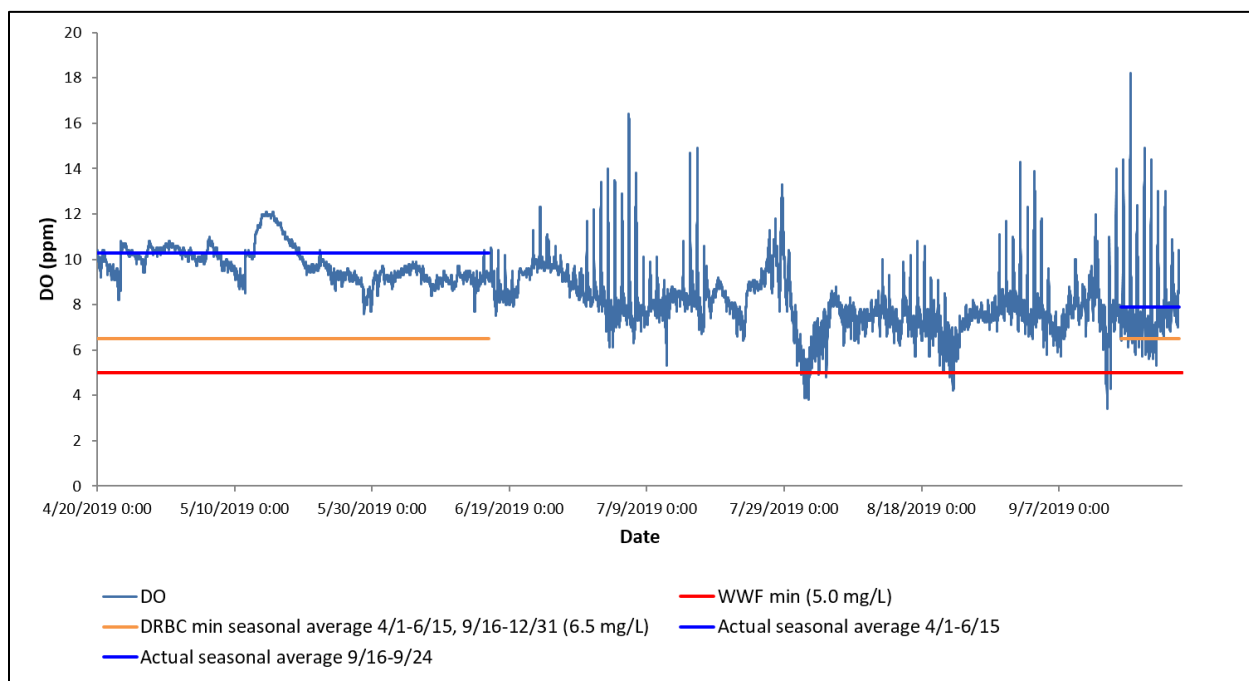
Figure 6. Continuous dissolved oxygen concentration measured by DO sensor, plotted with WWF DO minimum (5.0 mg/L), DRBC minimum seasonal average for 4/1 to 6/15 and 9/16 to 12/31 (6.5 mg/L), and actual averages

We are also concerned about our findings of water temperature and dissolved oxygen (DO) levels in violation of DEP criteria for warm water fish (WWF), and the implications for river health. Temperature measurements from our sensor station have, on multiple occasions, exceeded WWF criteria (Figure 5), and this season we saw DO fall below the WWF minimum of 5.0 mg/L assigned by DEP (Figure 6). DO levels appear to be meeting DRBC criteria (seasonal averages of at least 6.5 mg/L and 24-hour averages of at least 3.5 mg/L), though with instantaneous minima as low as 3.4 mg/L. It is confusing to navigate the relationship between DEP and DRBC criteria in cases such as this, in which DEP defers to DRBC for a segment where DEP criteria still apply. We believe additional monitoring by DEP and/or DRBC would be helpful to better understanding water quality in the tidal Schuylkill, but there needs to be a clearly articulated approach to assessment when two agencies have authority.
