# Quantifying Sediment Sources in the Pickering Creek

Stormwater at SL113

# Quantifying Sediment Sources in the Pickering --Experimental Design

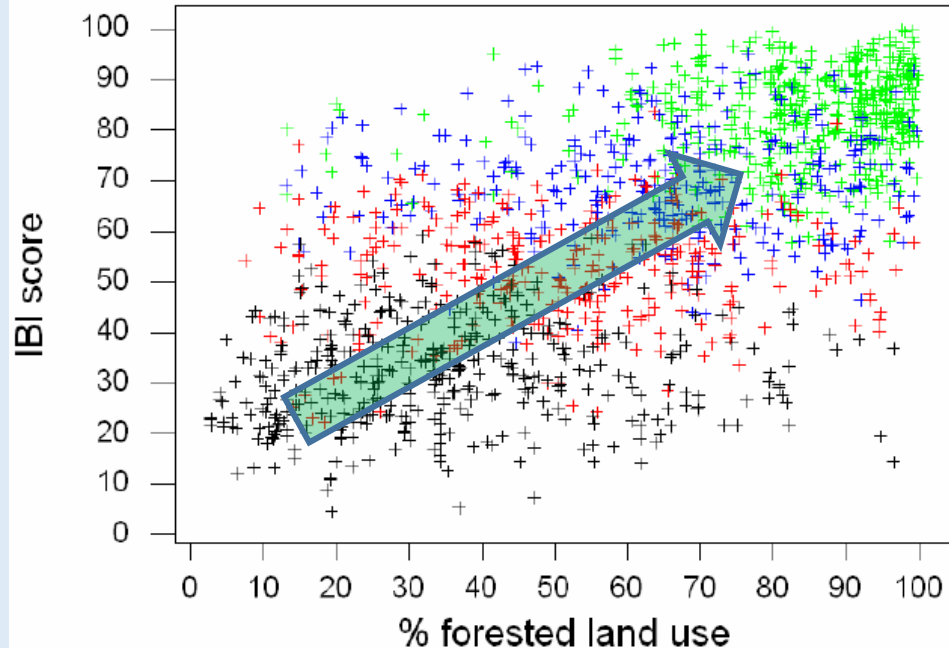
Increasing forest cover acres, increase in riparian forest, and increase in forest biomass per forest acre

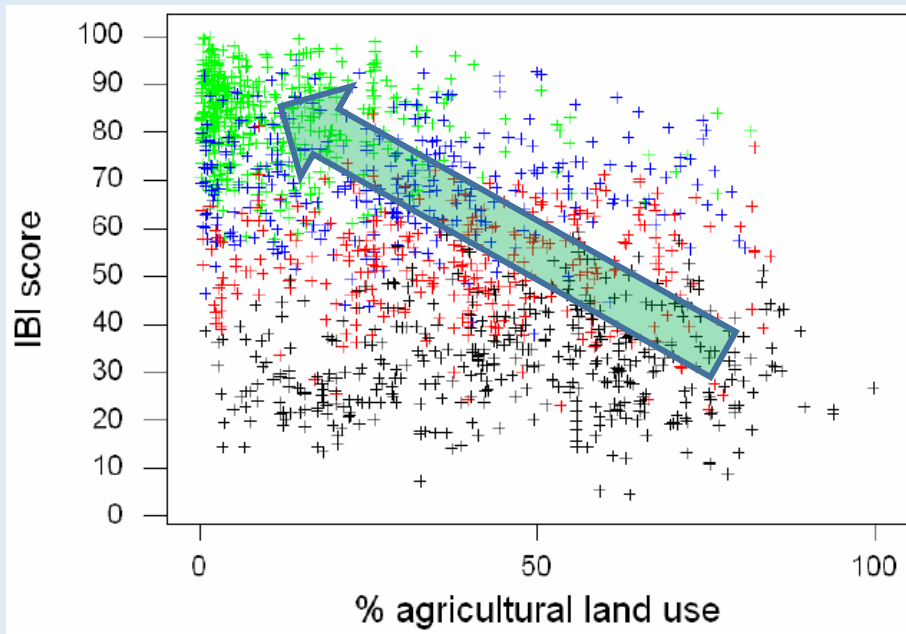
Decreasing ag lands acres *and* decreasing soil loss *per* acre

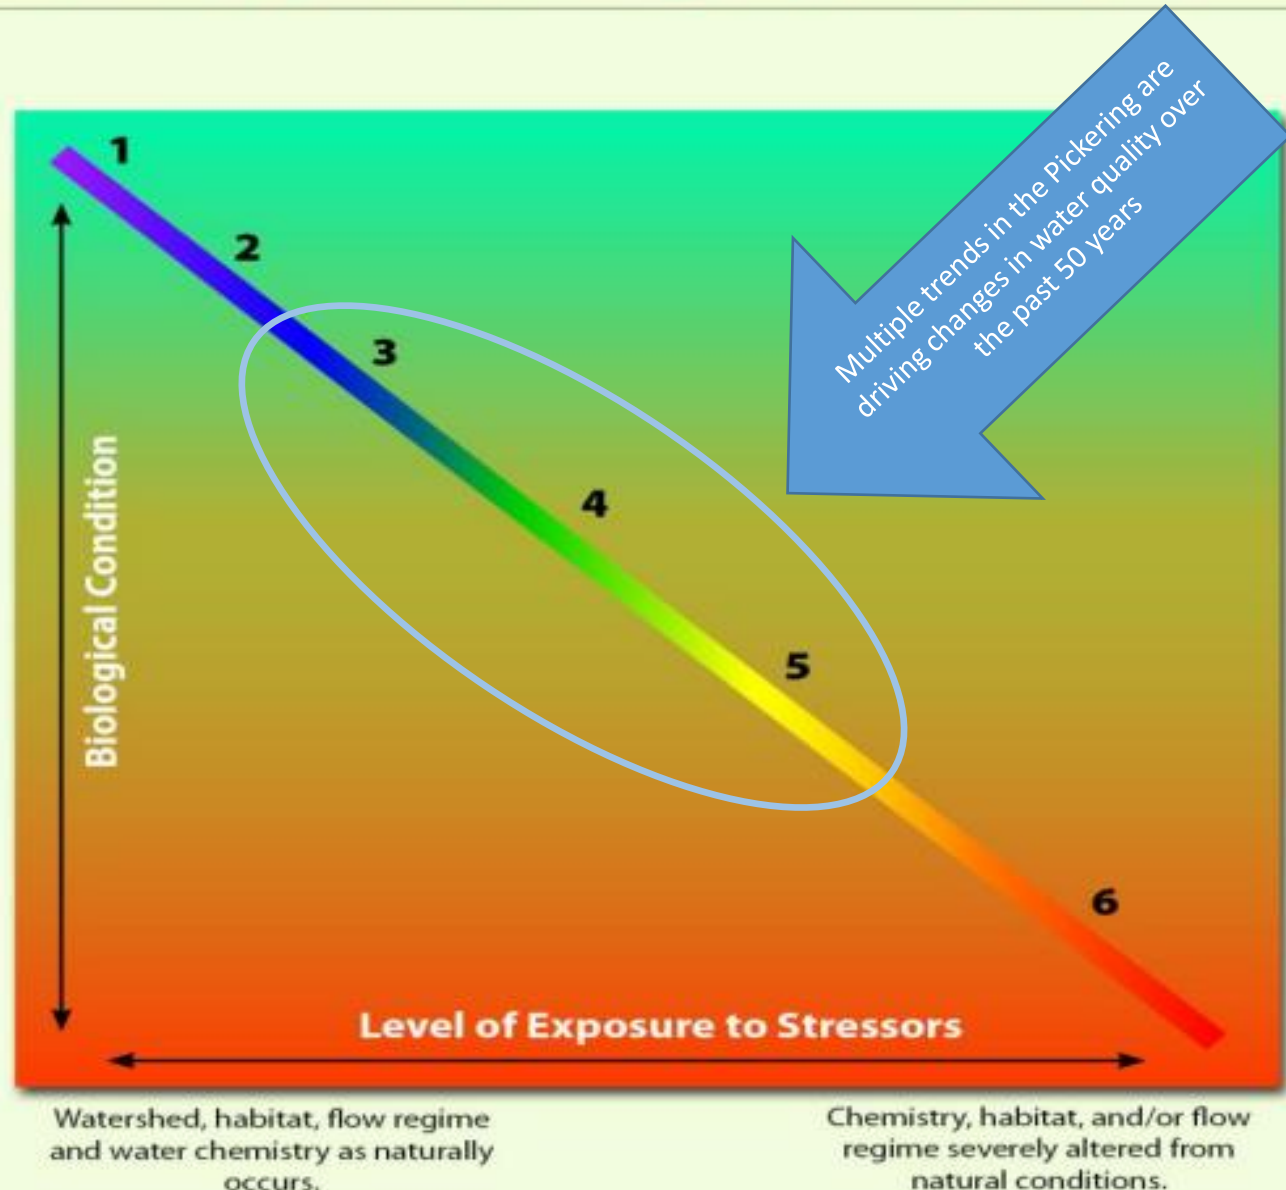
# The Biological Condition Gradient: Biological Response to Increasing Levels of Stress

Figure from The Biological Condition Gradient – a conceptual model depicting stages of biological condition responses to an increasing stressor gradient – Davies and Jackson (2006)

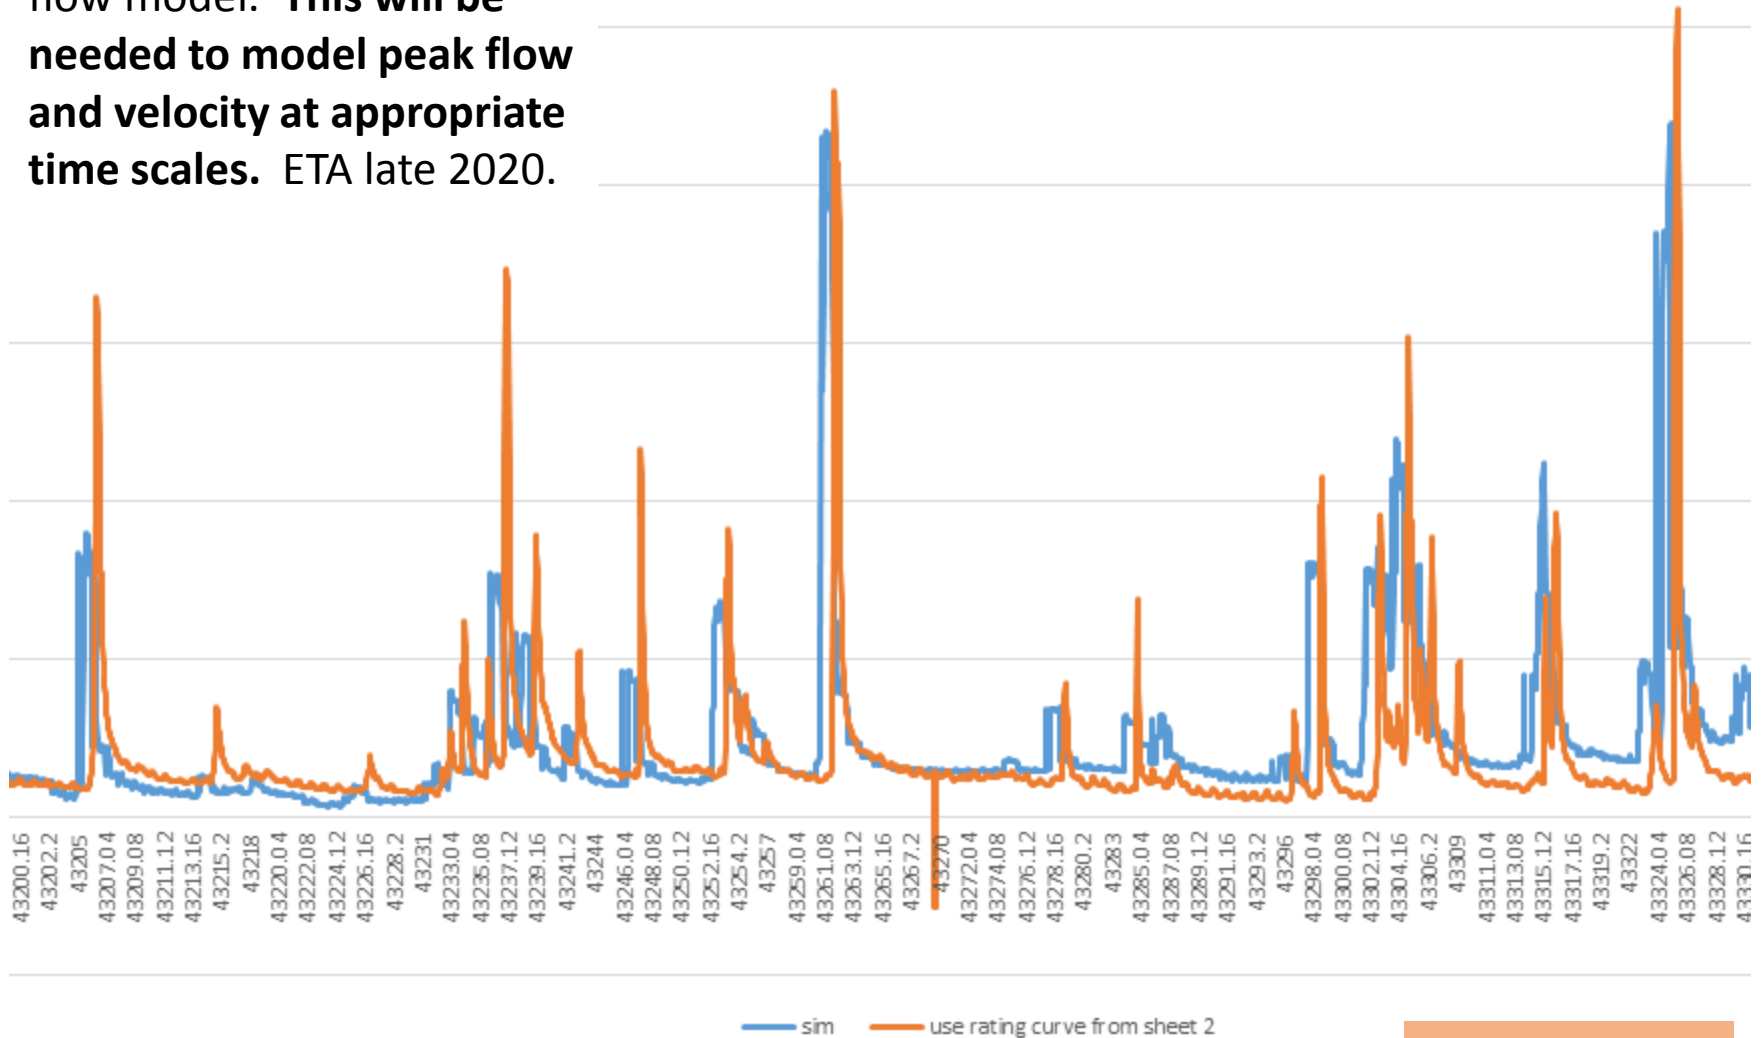
## Hourly Modeled Flow versus Observed at SL138

Developing an hourly SWAT flow model. **This will be needed to model peak flow and velocity at appropriate time scales.** ETA late 2020.

Not Validated

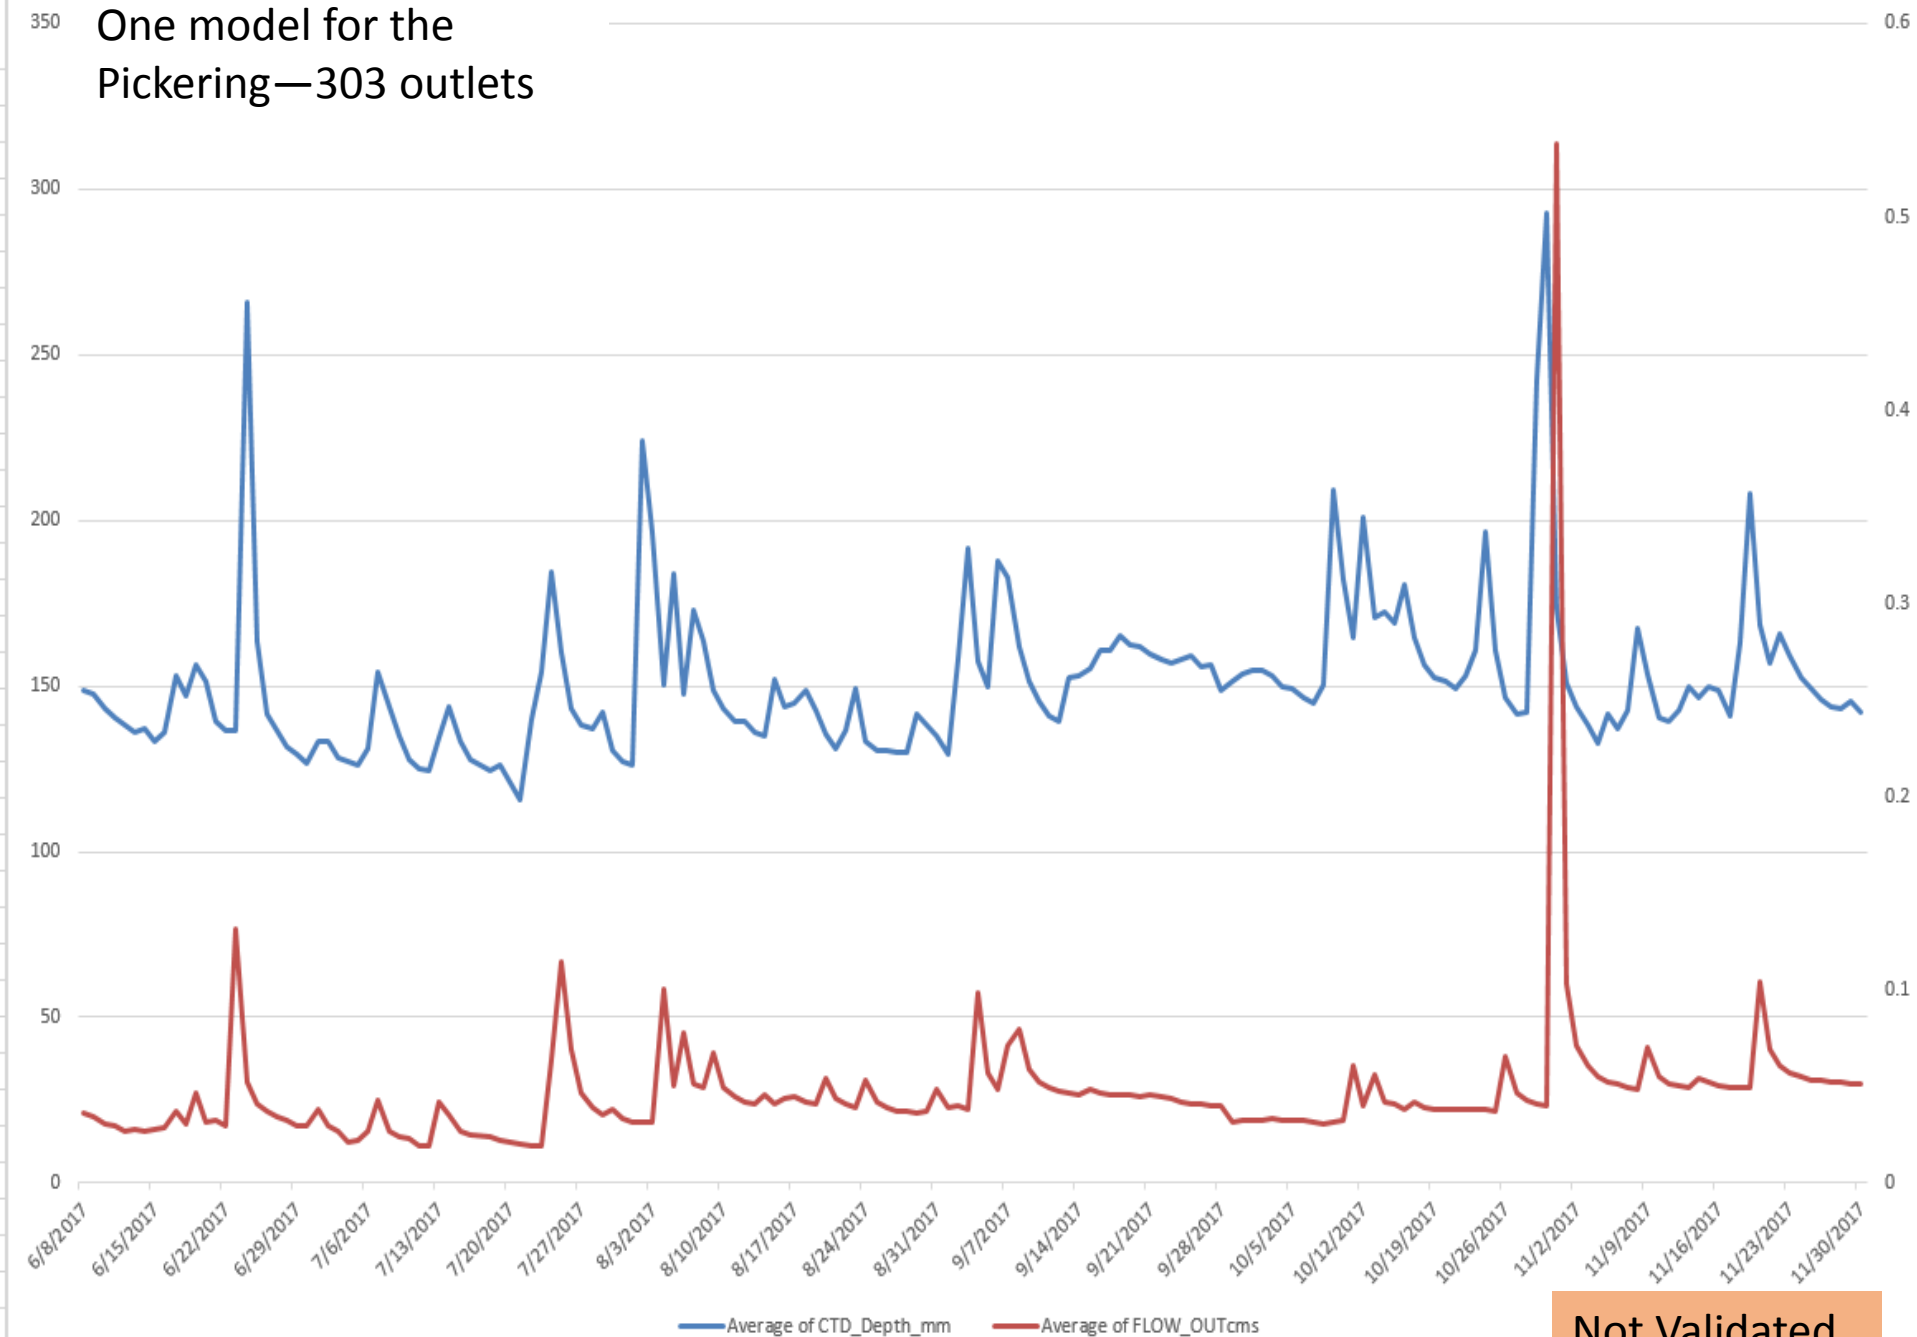
Modeled Daily Flow versus Observed Depth at SL 114

One model for the  
Pickering—303 outlets

Not Validated

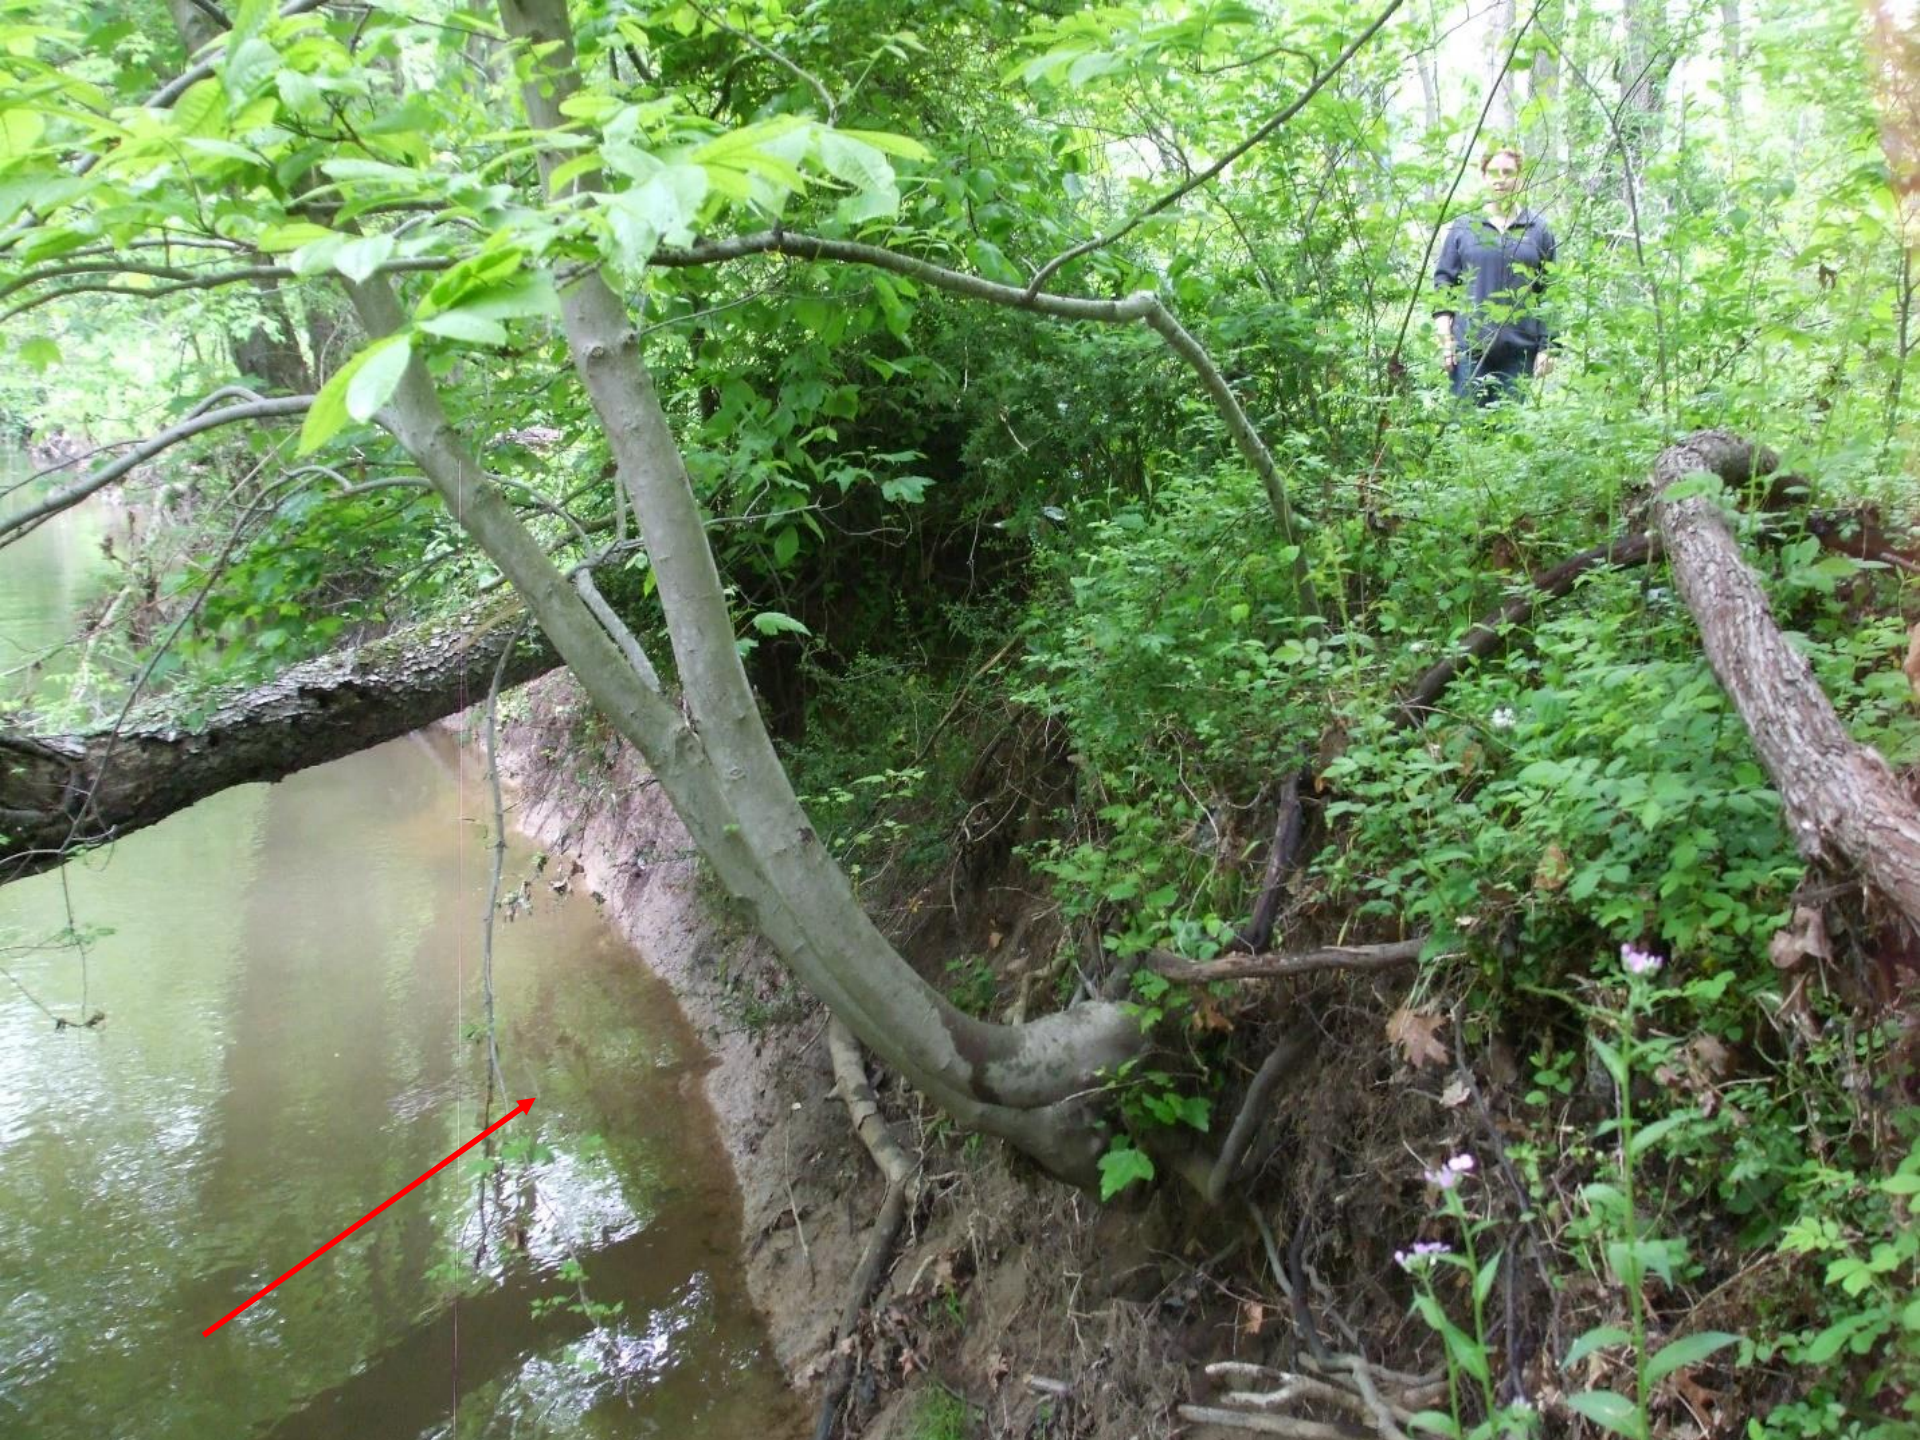
3d model of stream bank in Pickering Creek
