# Great Marsh Institute

Supporting the Mayfly water sensor loggers at Great Marsh

# Phragmitus invasion in Great Marsh

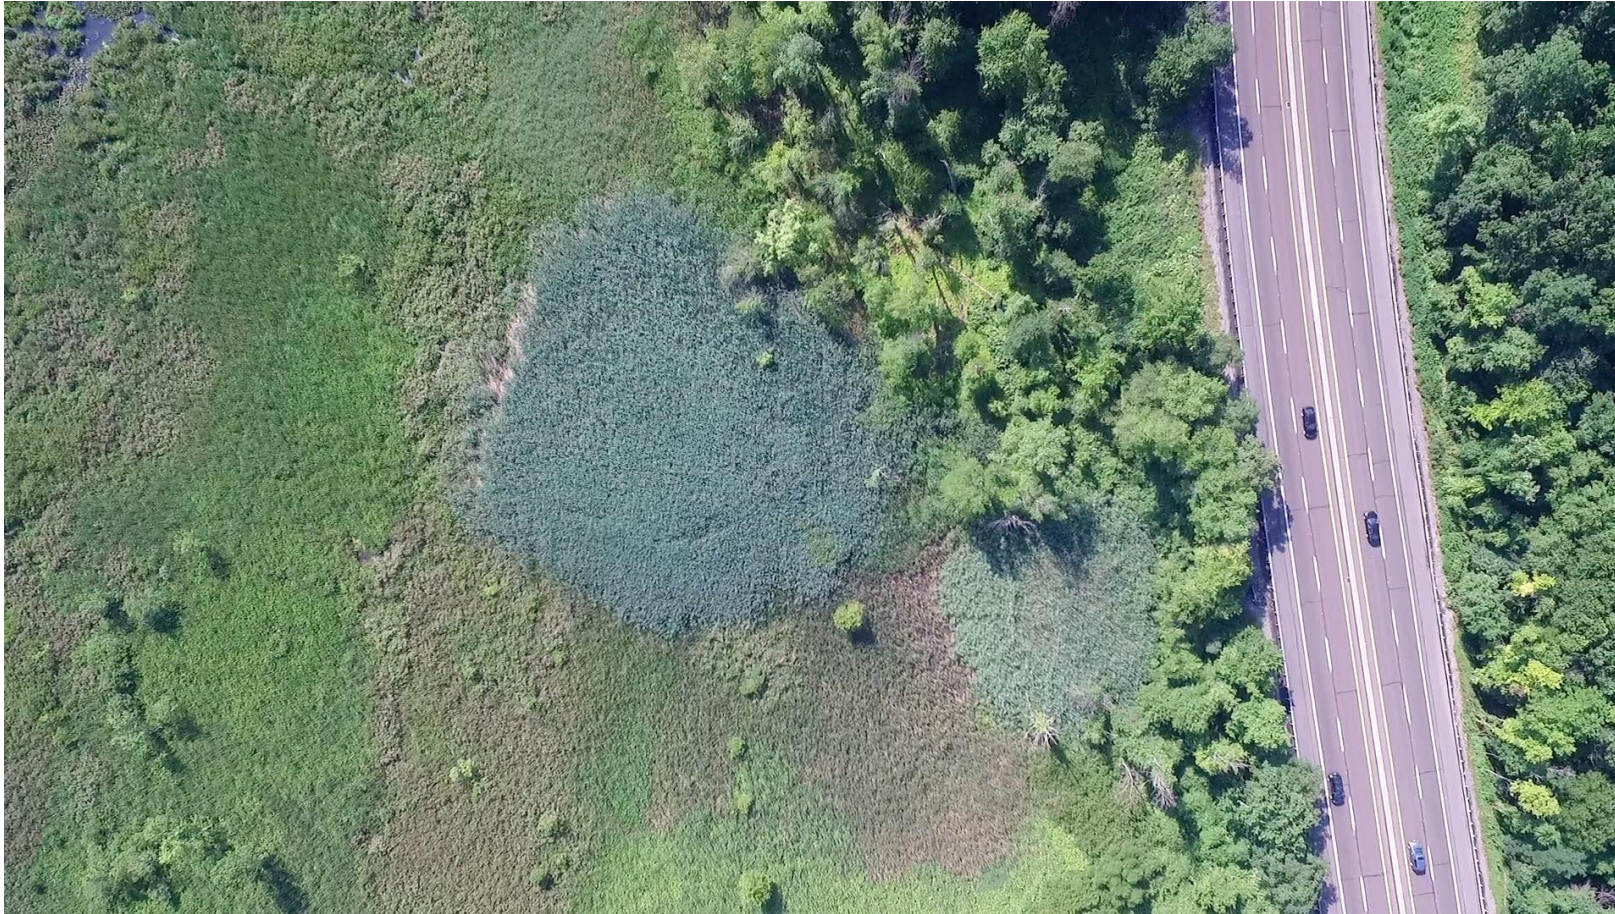
Phragmites visible as blue-green area

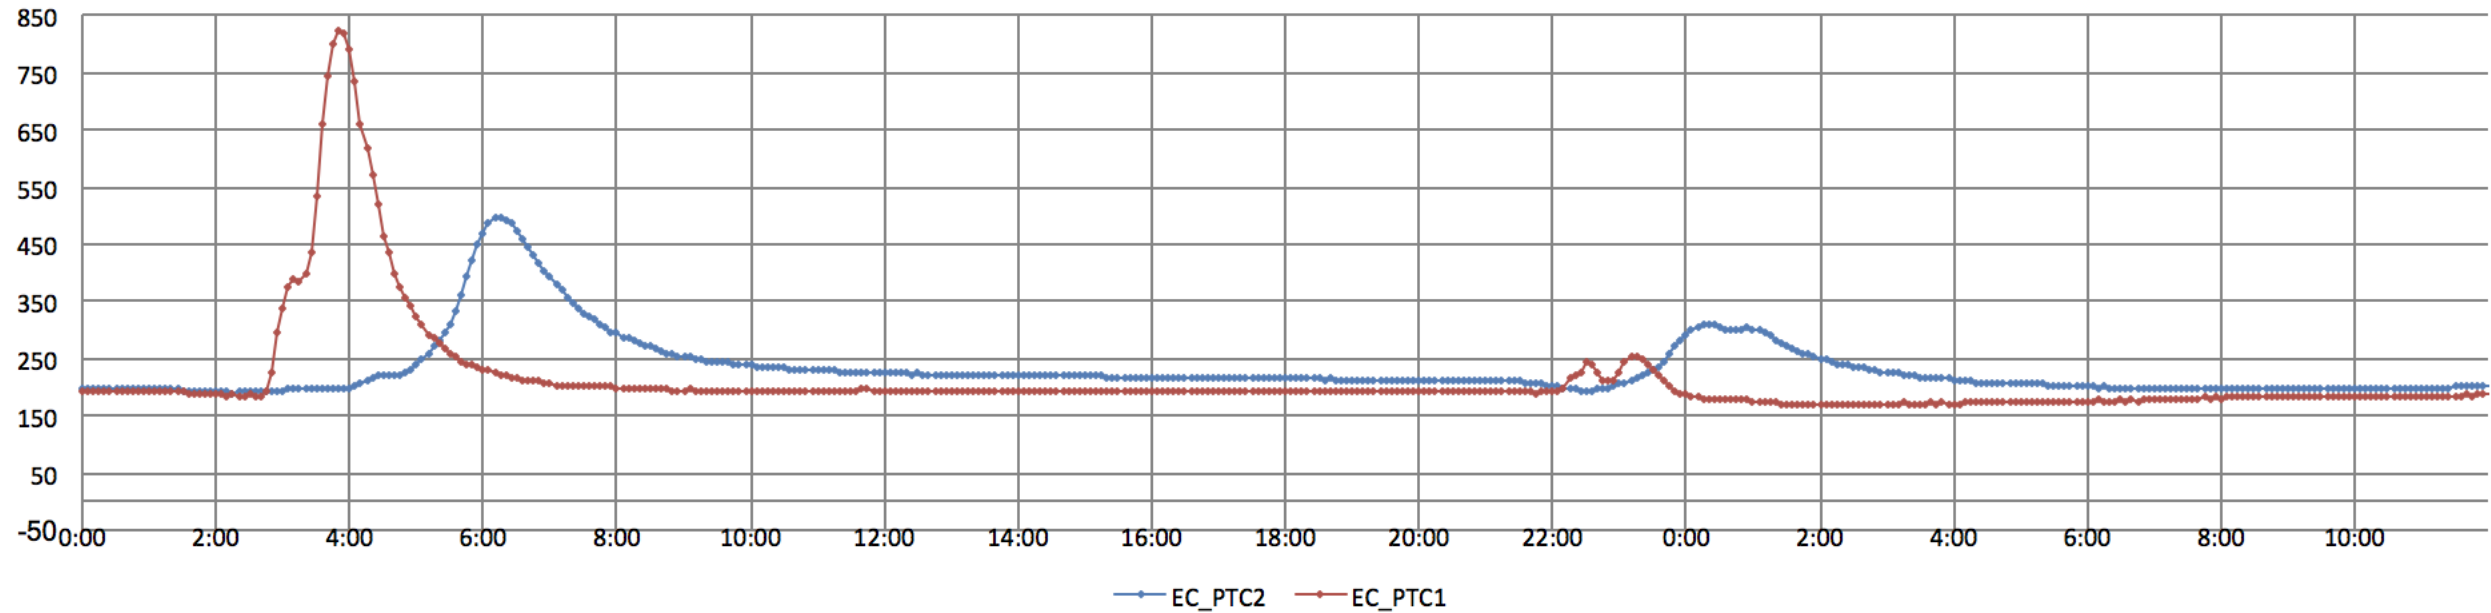
# PTC\_1(red) and PTC\_2(blue) 1/8/2019

Showing time delay for a storm water runoff event at  
the turnpike culvert underpass (PTC\_1)

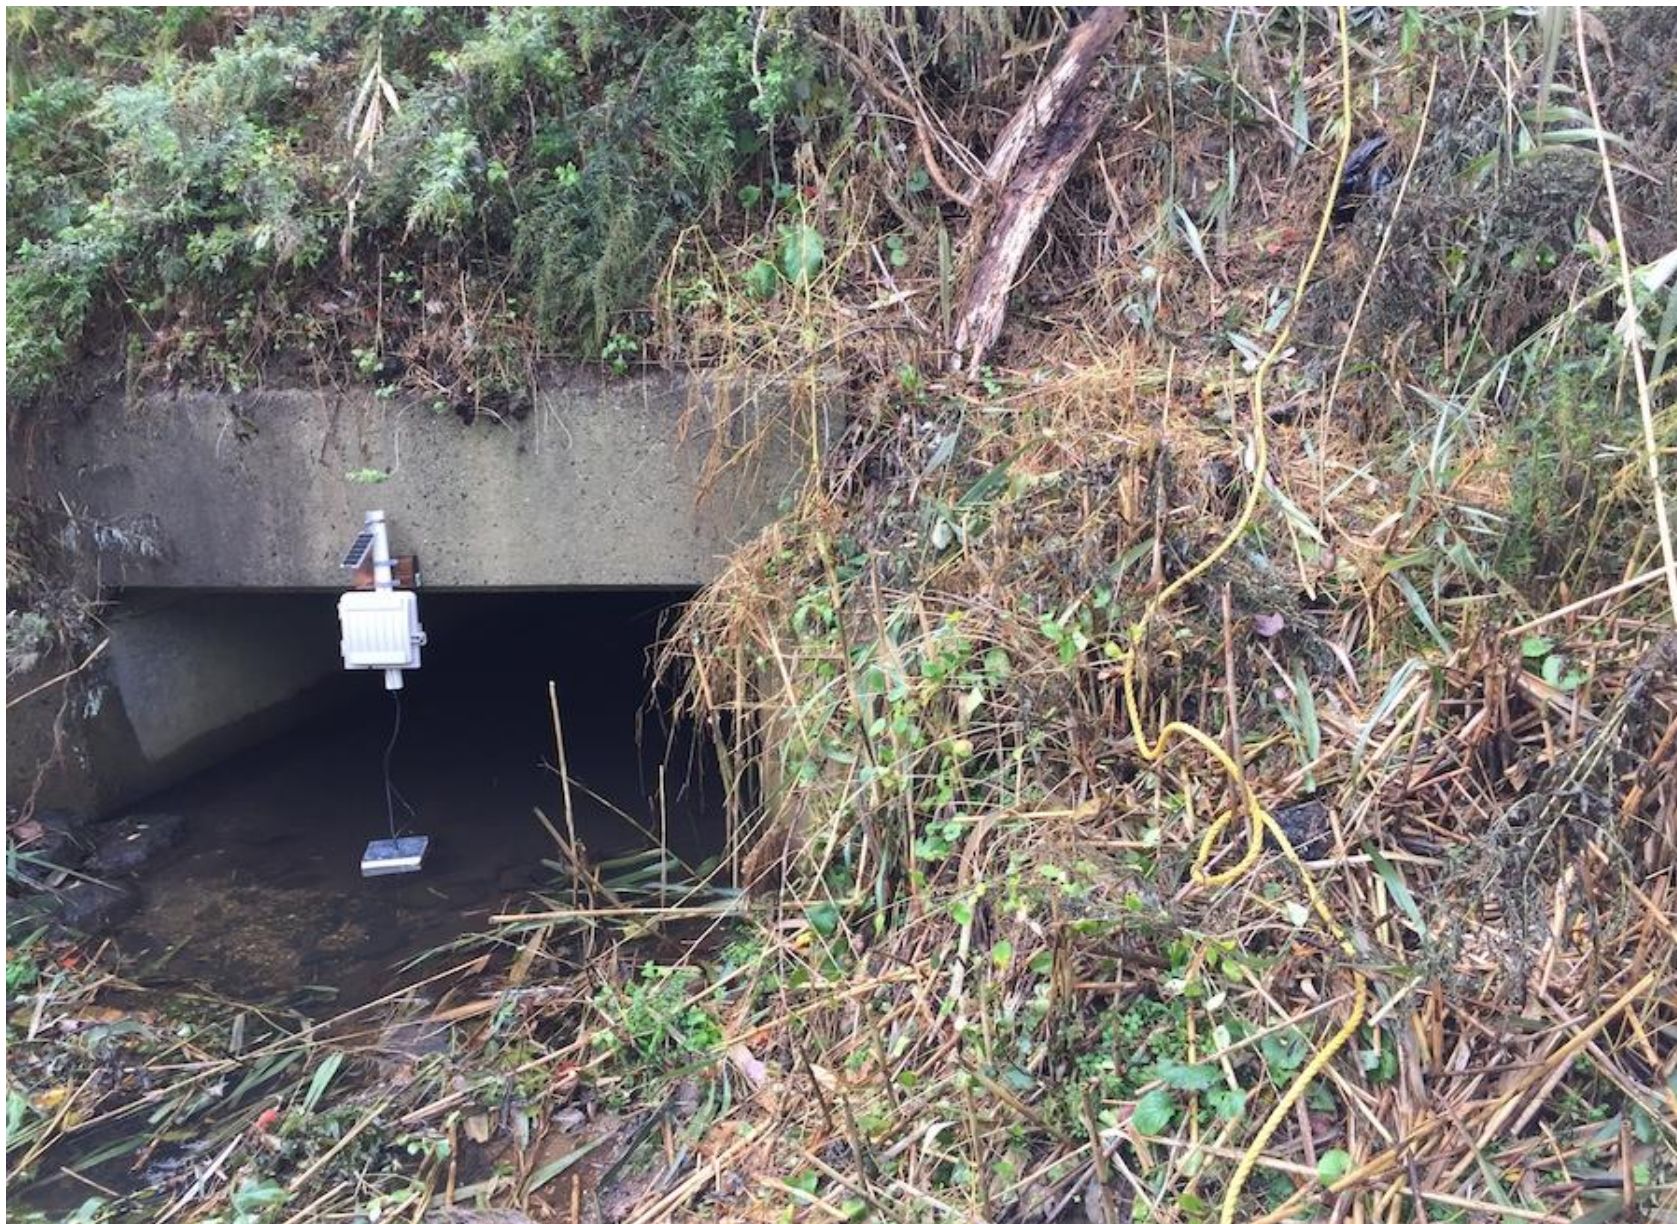
PTC1 located on a culvert that crosses under the Pa Turnpike

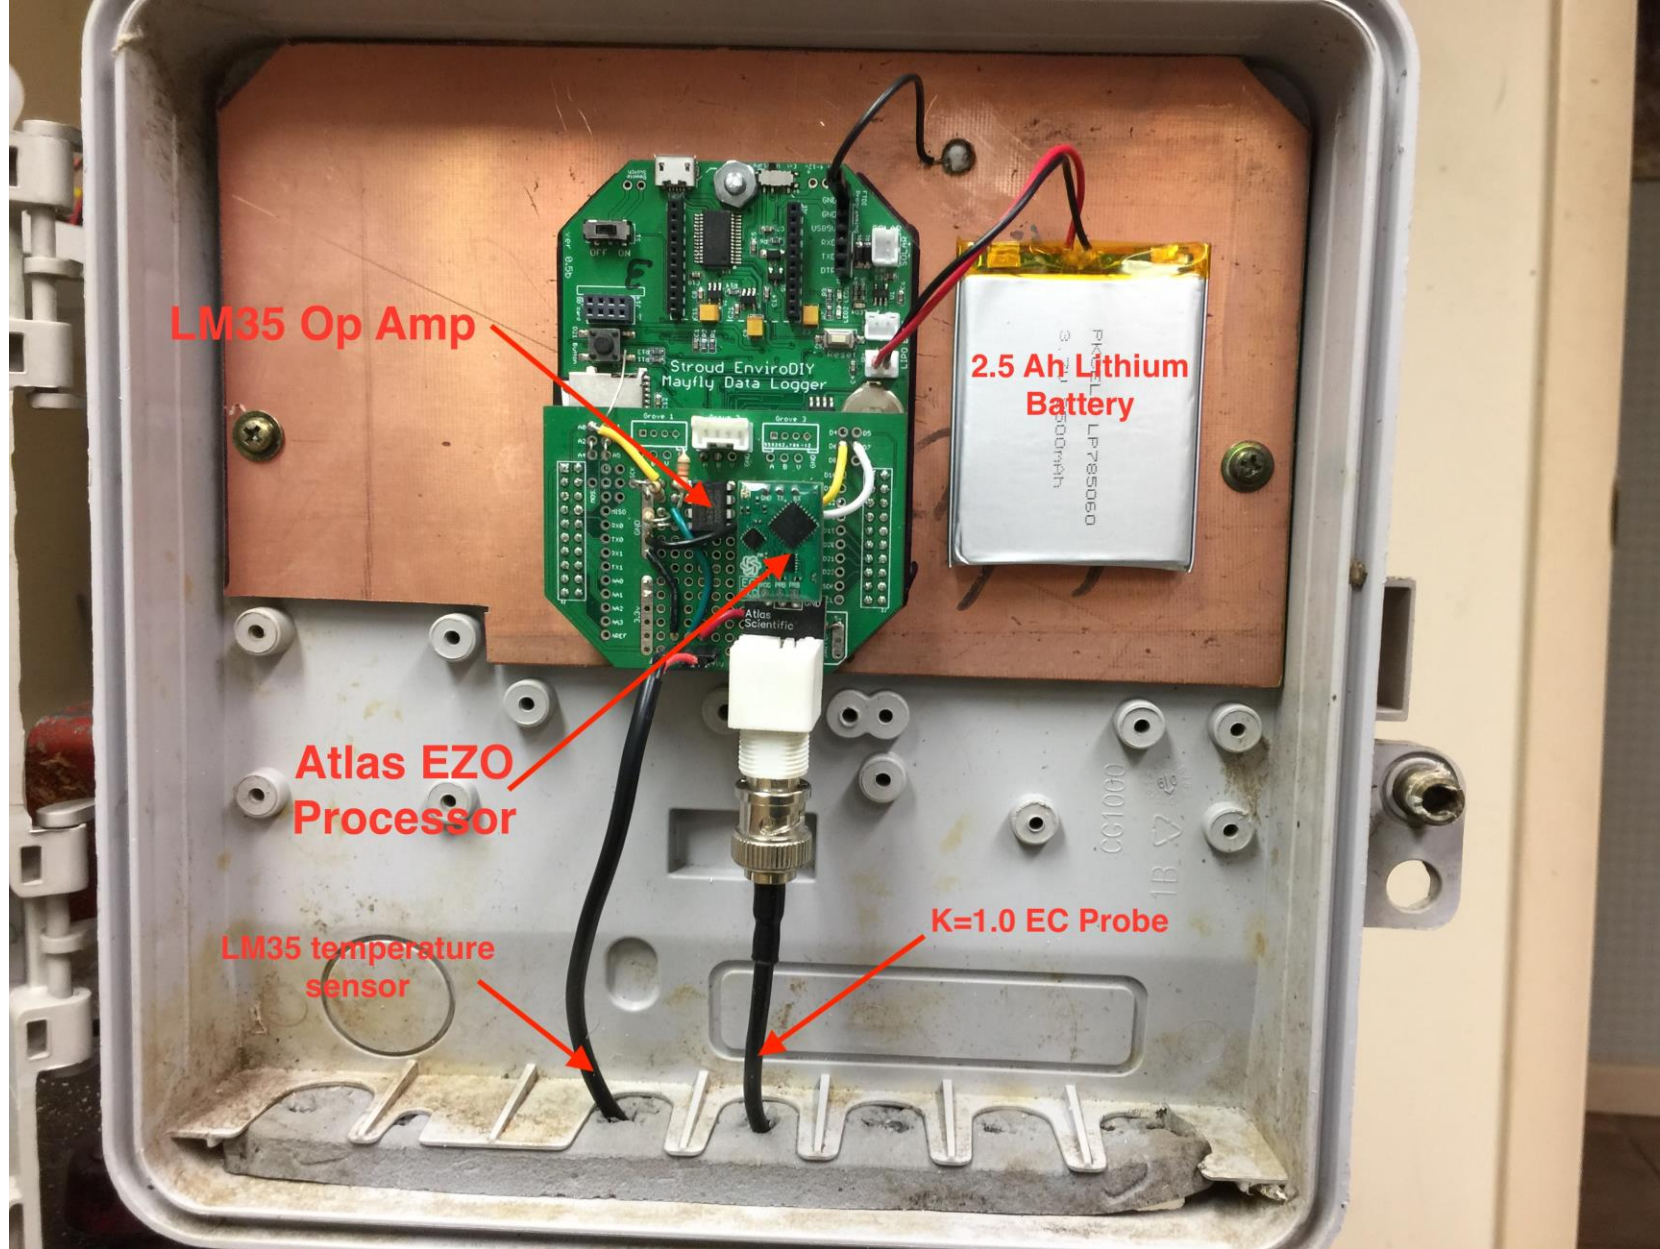
Mayfly based EC and temperature logger

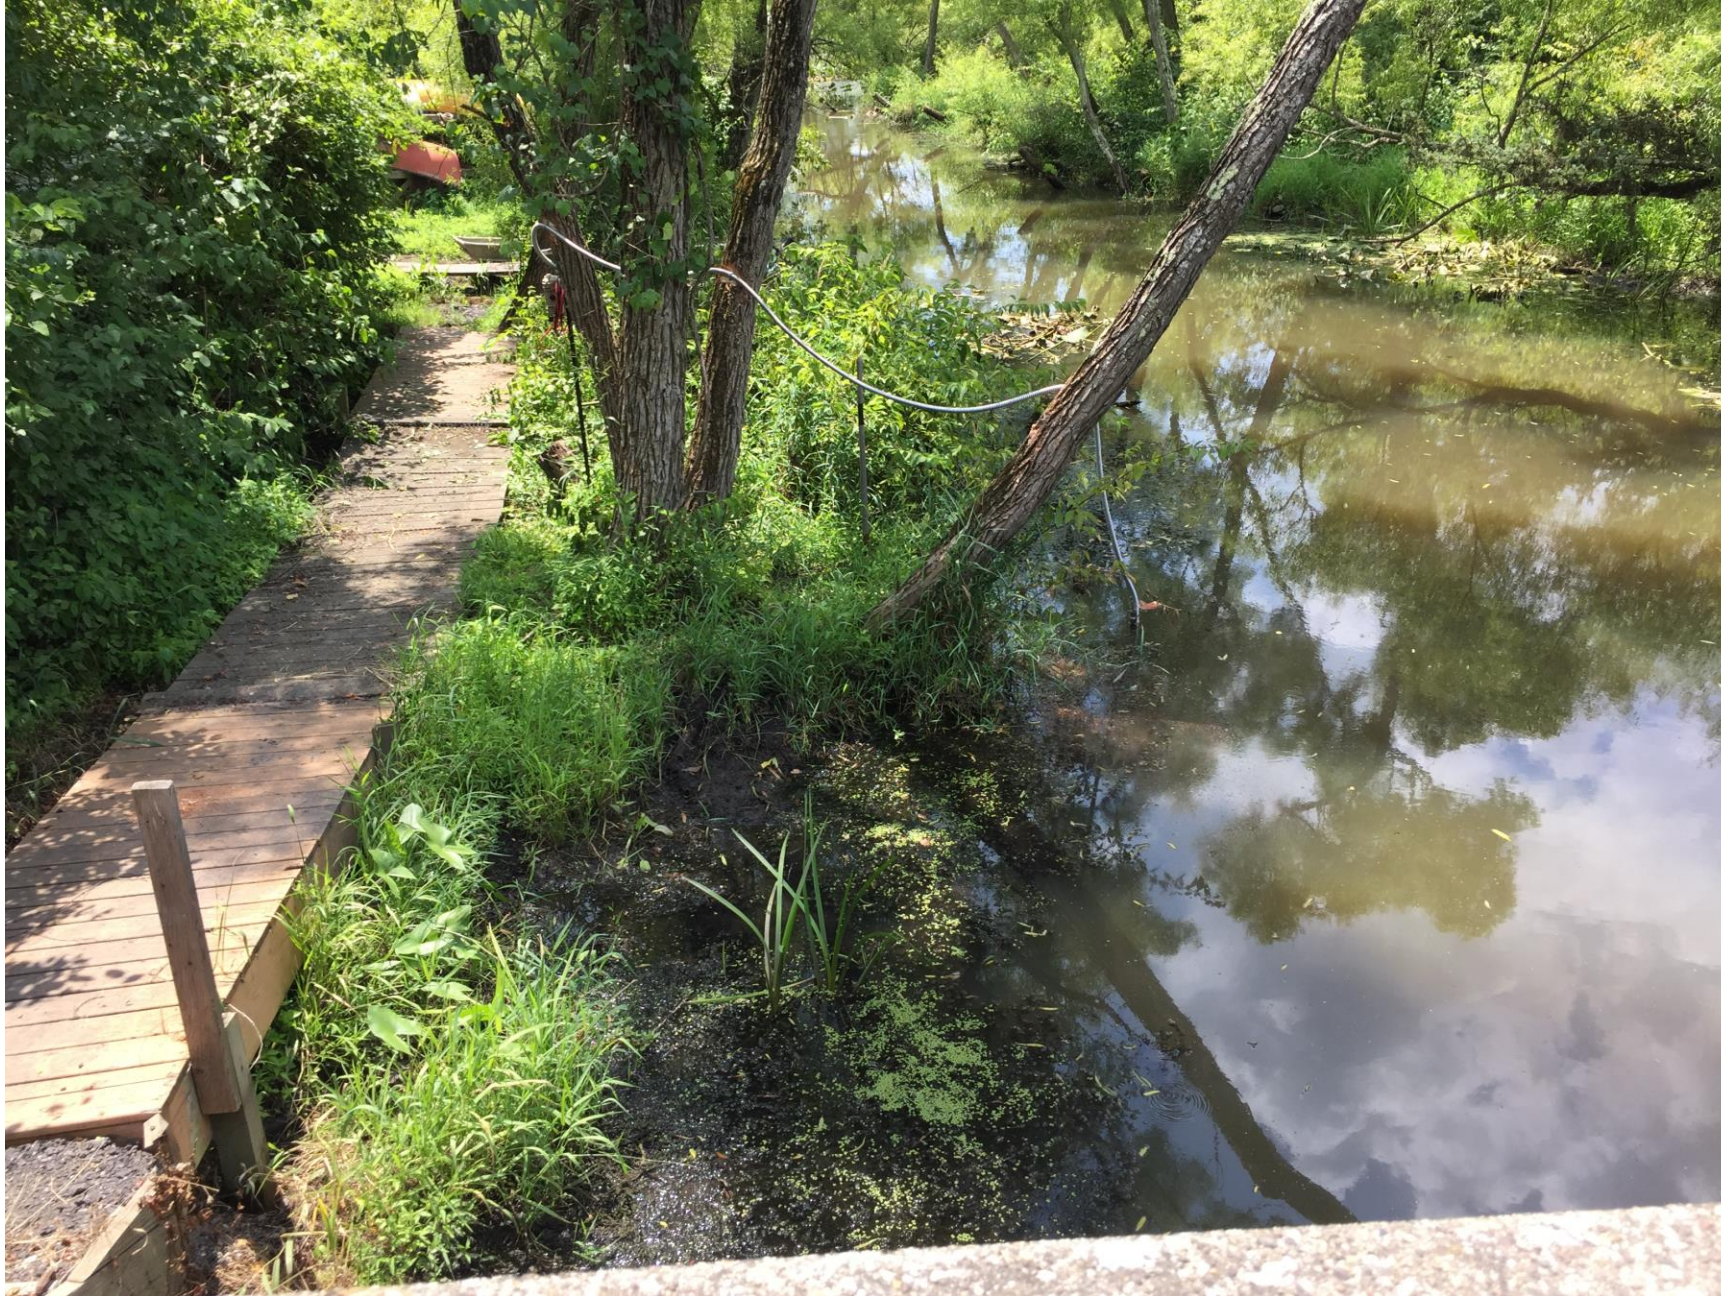
Beaver proofing SL149

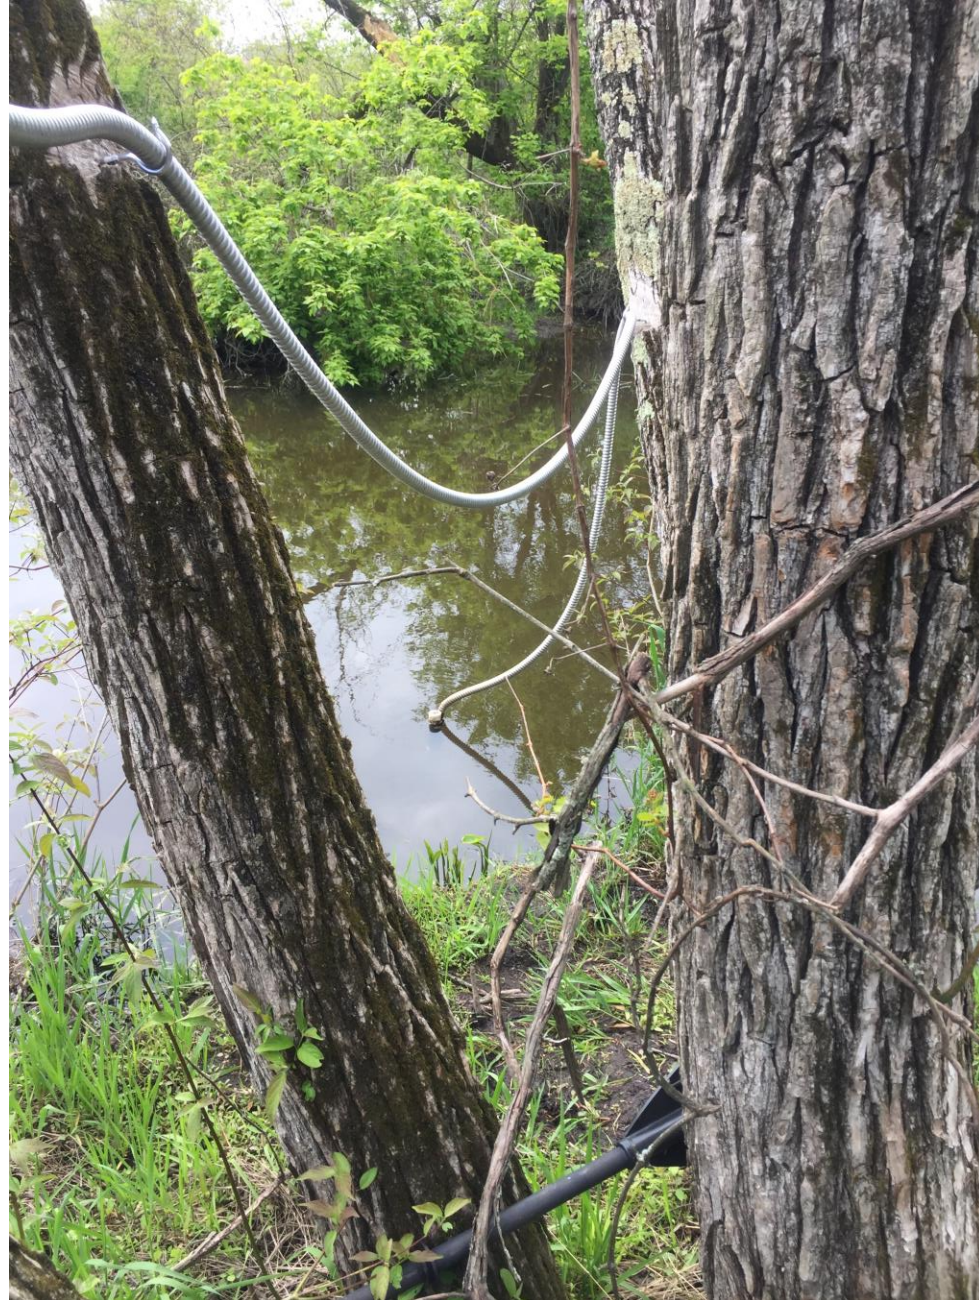
Beaver proofing (cont)
